CORRELATING THE PRESENCE OF POPCORNEED BGA DEVICES POST REFLOW WITH SOLDER-BALL DIAMETER MEASUREMENTS FROM X-RAY INSPECTION

ABSTRACT

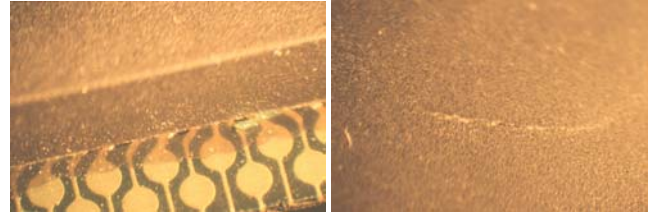
Image 0: Left image – side shot of BGA with crack between the plastic cover and the BGA substrate. Right image – crack on top surface of plastic BGA.

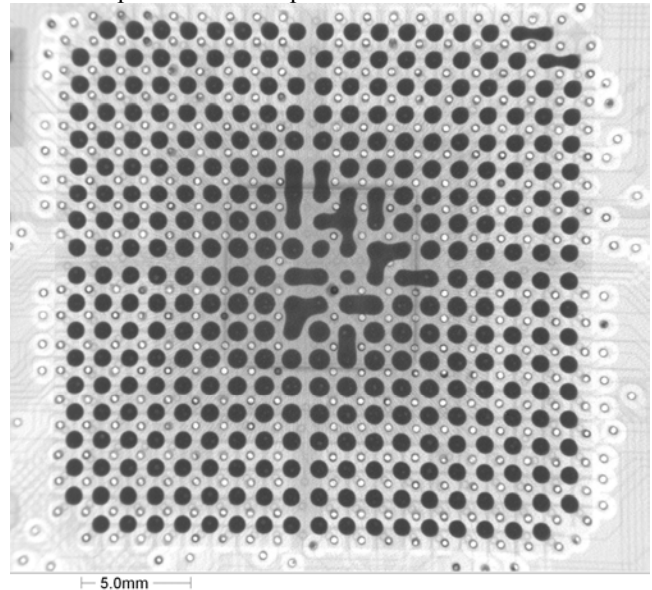
Image 1: Bridges seen in x-ray image under BGA following device popcorning.

The popcorning of BGAs is often indicated by the presence of bridging under the device. This is caused when the expansion of the package during reflow causes it to 'dish', where the underneath of the package deforms and presses down onto the solder balls underneath. As the solder is liquid at the time, it allows the solder from adjacent balls to coalesce and so produce bridges. These are very clearly seen in the x-ray image (see image1).

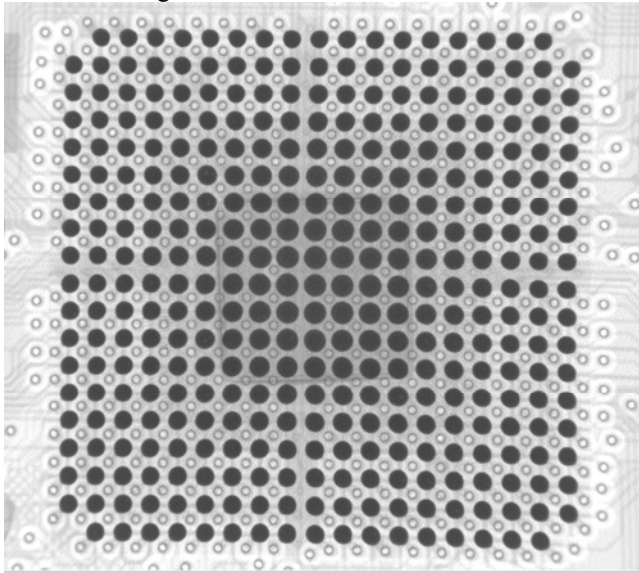
Whilst bridging between solder balls is a very common indicator of a popcorned BGA, it is possible that bridging does not always occur. In such cases there will still be evidence of the package deformation because the ball diameters across the BGA will not be consistent. Instead, solder balls at the centre of the package would be expected to be larger in diameter (where they have been pressed down), with the other solder ball reduced in size as the edges of the package have been lifted. Such a situation can be seen in image 2.

Image 2: X-ray image of a popcorned BGA, where the central solder balls are much greater in diameter than the outer solder balls but bridges have not formed.

This analysis can be confirmed through an investigation of the solder balls at oblique angle views in the x-ray system. Where there reflow is good then there is a consistency of the solder joints with a typical shape seen in image 3. In contrast, the central solder balls of image 2 when seen at an oblique angle look as shown in image 4. Although there is no bridging in image 2, the difference in solder ball diameter between the inner and outer solder balls is very clear. So this solder ball diameter variation is sufficient to flag this device for at least further investigation, or, more likely, replacement. Therefore measuring and comparing the BGA solder ball diameters offers the opportunity to identify popcorning even if the most obvious signs (bridges) are not present in the x-ray images.

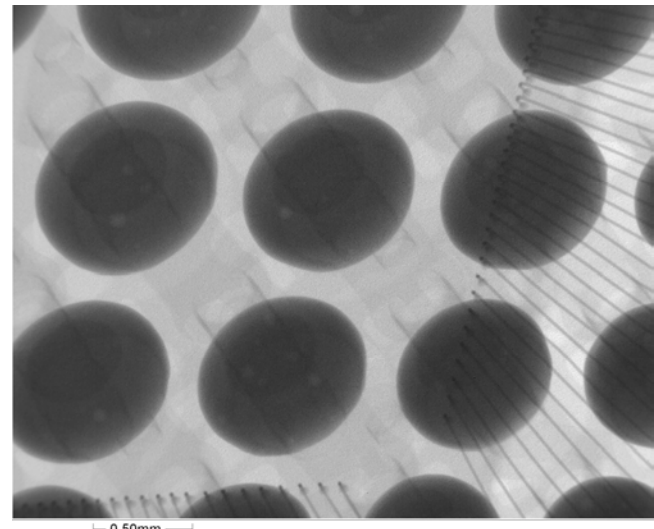
Image 4: Typical x-ray image of popcorned solder balls such as those seen under the centre of the BGA device in image 2.

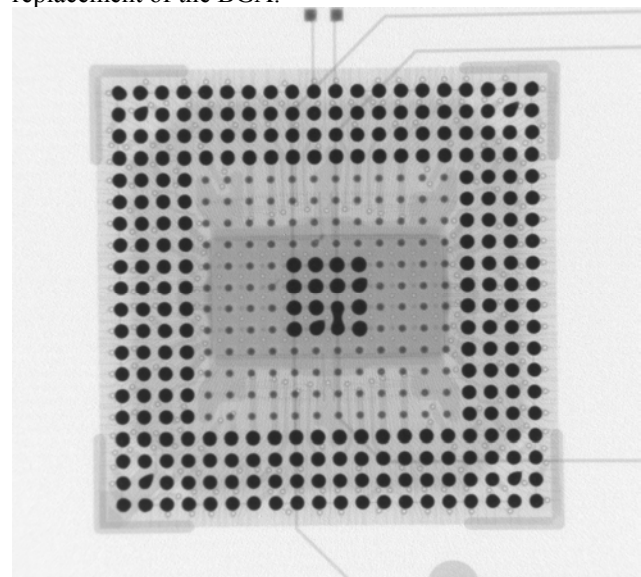
The success of (mal)-treating the BGAs prior to reflow resulted in all of the BGAs exhibiting some bridging under the central part of the BGA, irrespective of board finish and reflow method used. These bridges can be clearly seen in the x-ray image (see image 6) and this observation would be sufficient on its own to demand re-work and replacement of the BGA.

Image 6: X-ray image of BGA on gold finish board (designated Gold 7) following convection reflow. A bridge under the central part of the device is clearly seen.

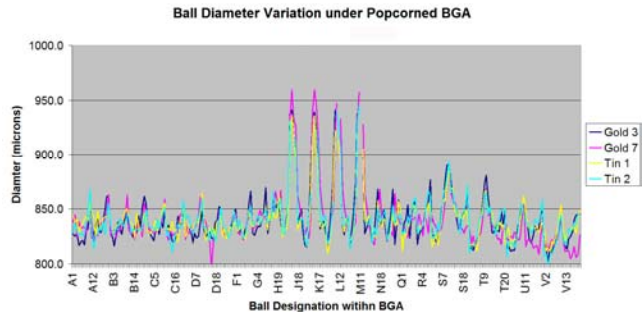
Figure 1: Normalised solder ball diameter measurements.

Figure 1 clearly shows a marked difference in the measured solder ball diameters between the central solder balls and those on the outside. This can be shown more clearly in figure 2, where the central solder ball measurements have been placed alongside, and on the same scale, as solder balls along two outside rows.

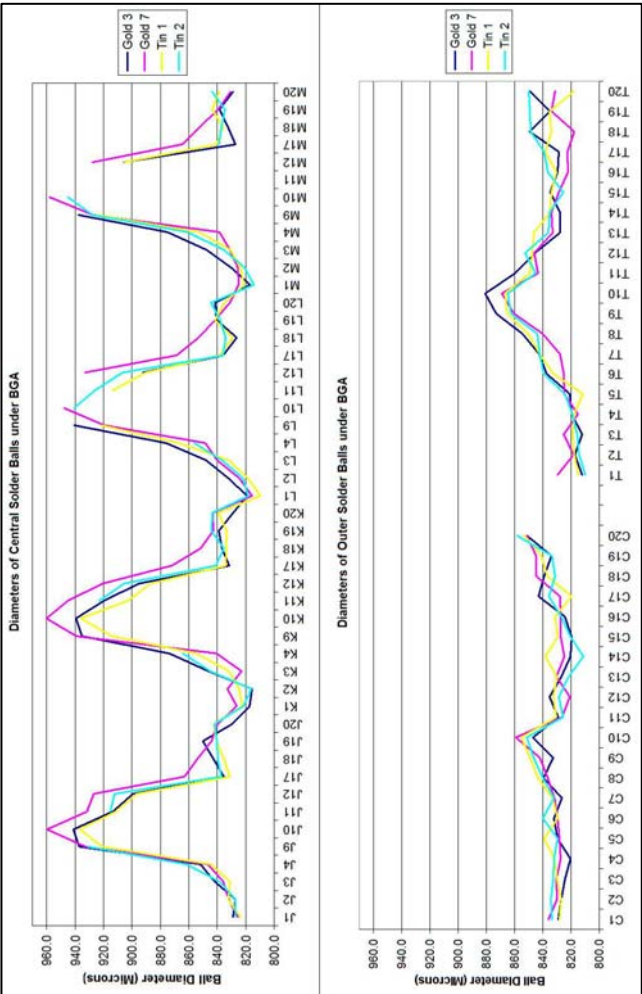
Looking at the data more closely, the average ball diameter for all of the measurements under the central area is $\sim 925 \mu\text{m}$. In contrast, the average ball diameter size in rows C and T of the device is $\sim 835 \mu\text{m}$. In other words, there is an approximate increase of around 11% in the central solder ball diameter compared to the outer balls. Such a diameter difference in percentage terms is large but, as can be seen from image 6, at low magnification this difference would not necessarily be obvious to an operator. Of course, the operator would immediately see the bridge in this example. However, if the bridge was not present then the escape of a clearly faulty board could occur if BGA measurements had not been taken.

Figure 2: Central solder ball diameters compared to outer row solder ball diameters under the same scale. Gaps in the data lines are locations of bridges seen under the devices.

It is suggested that a variation of more than 7% in the solder ball diameter compared to the average would strongly indicate that a problem may exist. This method will be more reliable than just looking to try and see delamination or die cracks manually within an x-ray image because of the lack of available density variation in the image owing to the additional densities present of board material and packaging. This approach also means that there is no need to consider immersing the board into water for scanning acoustic microscopic analysis, for example.
