# QUALITY AND RELIABILITY INVESTIGATION OF PRINTED CIRCUIT BOARD MICRO-VIAS BY X-RAY INSPECTION

David Bernard Dage Precision Industries Fremont, CA d.bernard@dage-group.com

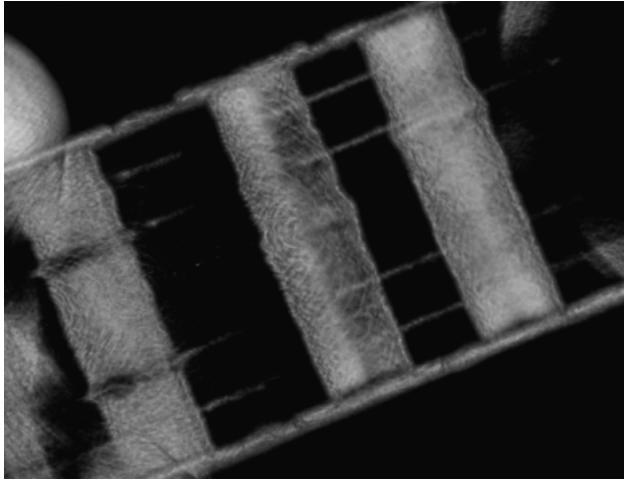
Image 2: 3D CT model image of micro-vias

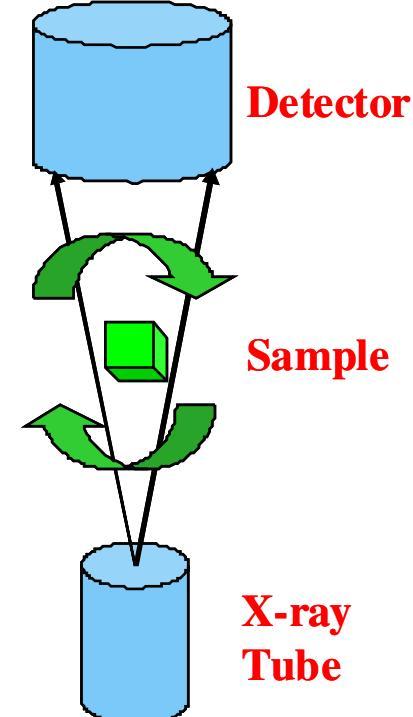
Diagram 1: Rotation of the sample perpendicular to the tube/detector axis is required for CT functionality. Images (projections) are taken at every step in the rotation.

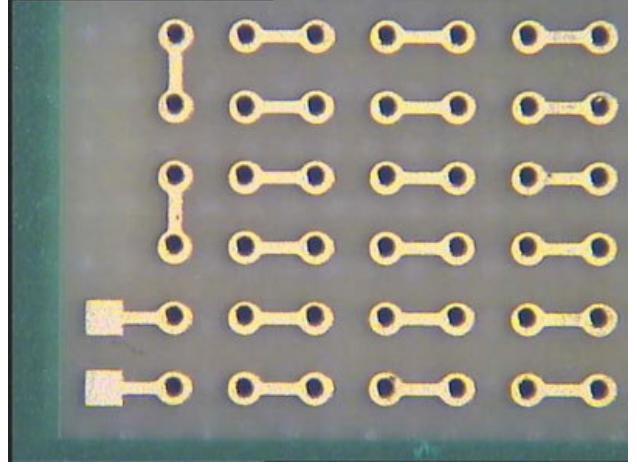
Image 4: Optical image of  $200\mu$  m diameter micro-vias used in the test vehicle.

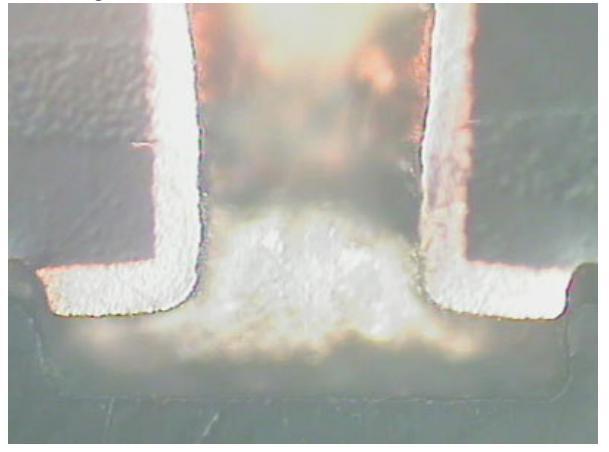
There was no evidence of failure on any of the test boards or any of the demonstration boards tested during this assessment. Selected micro-sections and x-ray examination failed to detect any issues with any of the samples tested (see images 6 and 7).

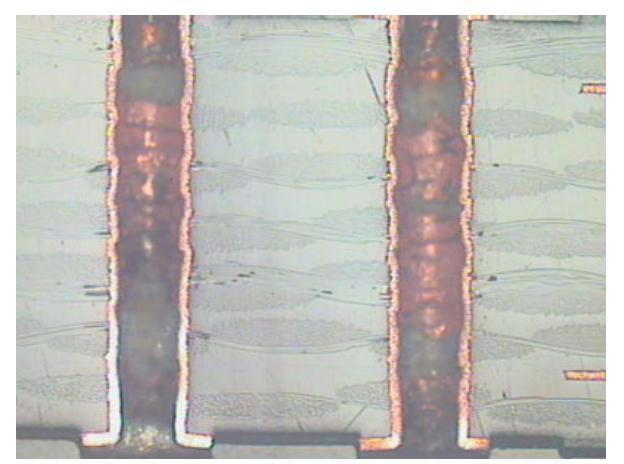
Images 6 and 7: Micro-sections of selected 0.2mm (0.008") holes after testing of OSP board

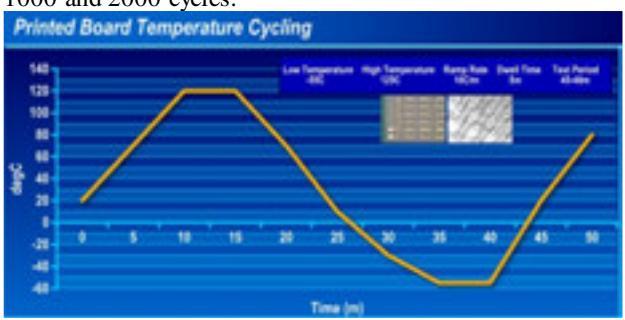
Image 8: Thermal cycling regime used on the test boards at the UK National Physical Laboratory

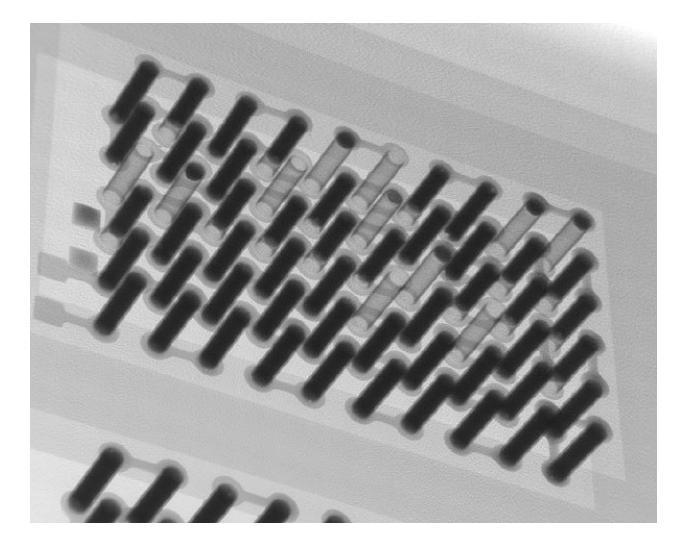
X-ray examination of the micro-via quality was conducted prior to assembly, after the soldering procedures and after 1000 and 2000 thermal cycles. Im ages 9 and 10 are the xray images of a wave soldered test board taken prior to thermal cycling. Images 11 and 12 are equivalent x-ray images from a convection reflowed board taken prior to thermal cycling. As there were no coupon failures in the micro-vias, even after 2000 thermal cycles, the x-ray images following the thermal cycling look the same as in images 9 - 12 and so are not repeated here.

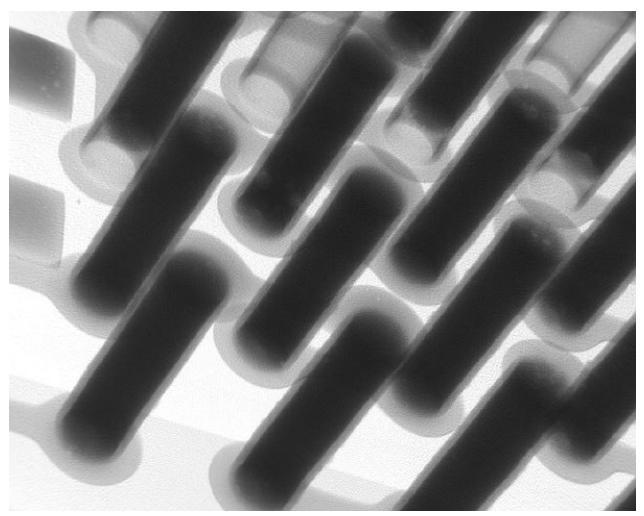
Images 9 and 10: X-ray images of a wave soldered test board prior to thermal cycling

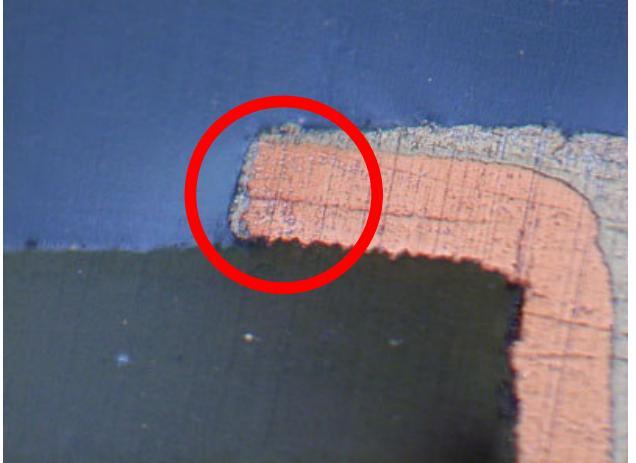
Image 13: Evidence of pad lifting caused by repeated expansion in the z-axis

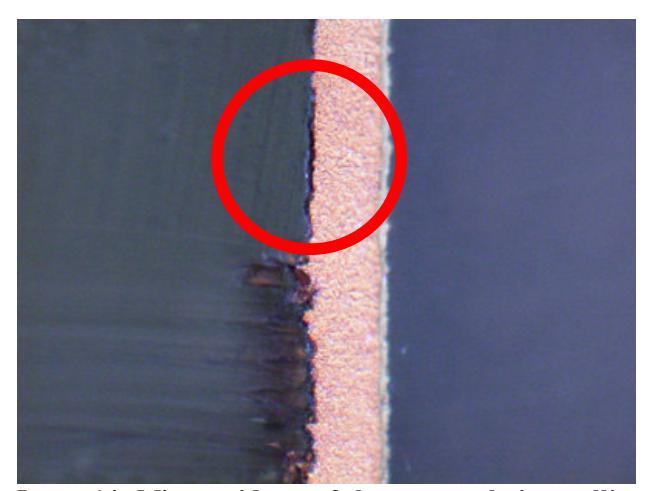
Image 14: Minor evidence of the copper plating pulling away from the hole wall. This is not uncommon on new high Tg laminates even without processing.

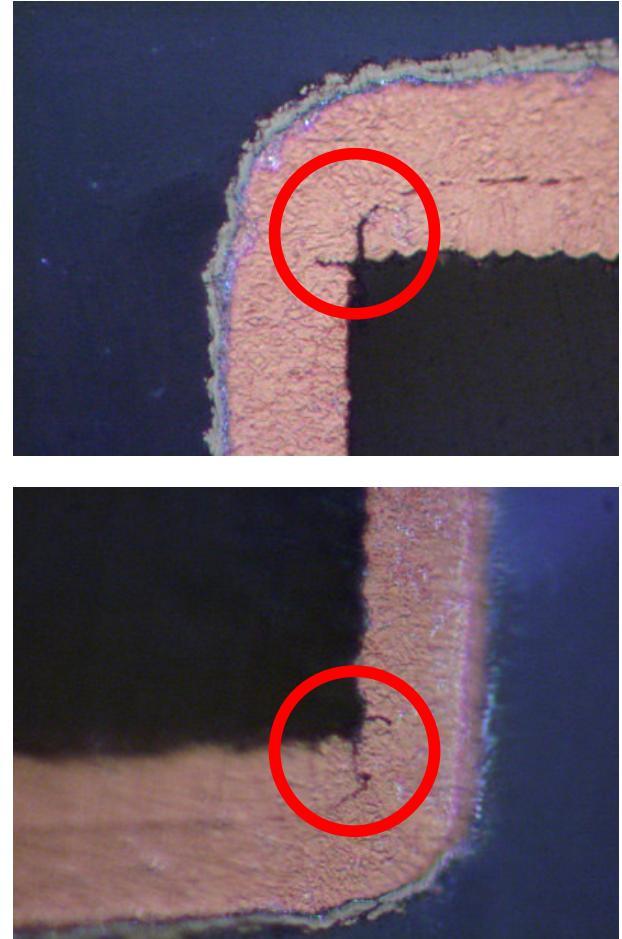
Images 15 - 18 below show minor copper cracking in the through-hole plating. In each of the examples, the copper is cracking in-line with the copper fail – as shown by the red circle. Normally in thermal shock testing, the cracking would be seen at the knee of the hole.

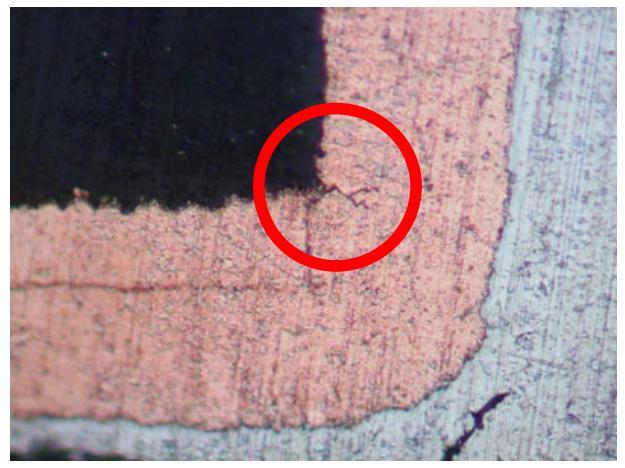
Images 19 and 20 below show two examples of laminate cracking that were observed during examination of the samples – as shown by the arrow location. This is often seen with high Tg laminate materials during mechanical testing after just one reflow operation due to the hardness of the resin.

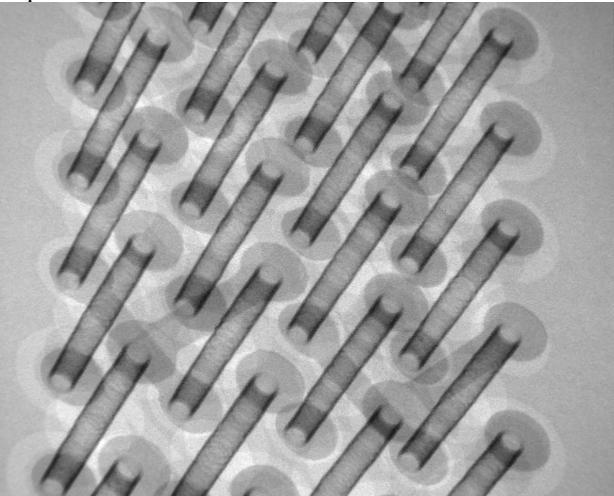
Image 21: 2D X-ray image at oblique angle view of NPL Studio Project micro-vias in a failed and visibly delaminated board

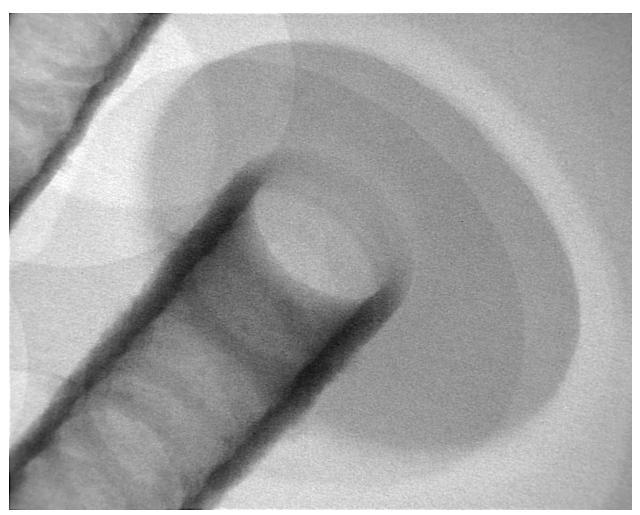
Image 22: High magnification 2D x-ray image at oblique view of part of a micro-via within a failed but visibly un-delaminated NPL board

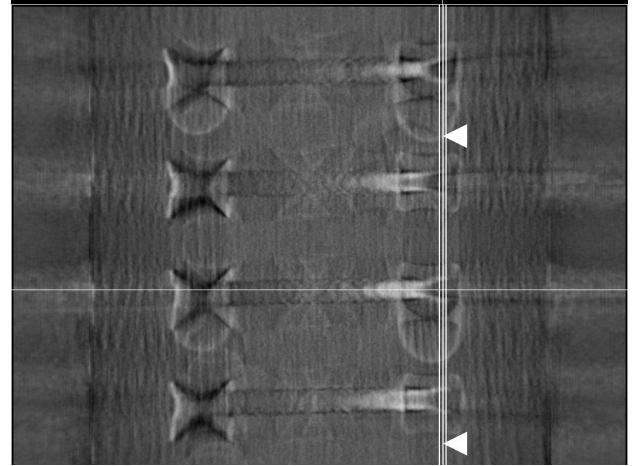
Image 24: 2D view from the CT reconstruction indicating the location relative to the micro-via depth of the cross-sectional slice shown in image 24 (between the white vertical lines).
