CORRELATING THE PRESENCE OF POPCORNEED BGA DEVICES POST REFLOW WITH SOLDER-BALL DIAMETER MEASUREMENTS FROM X-RAY INSPECTION

ABSTRACT

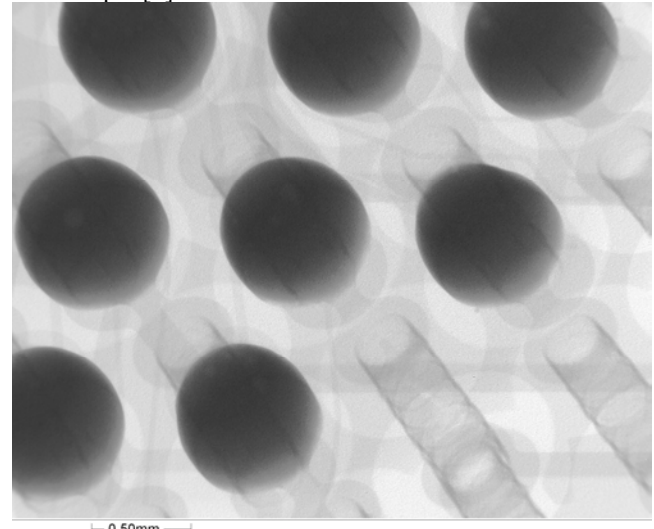
This analysis can be confirmed through an investigation of the solder balls at oblique angle views in the x-ray system. Where there reflow is good then there is a consistency of the solder joints with a typical shape seen in image 3. In contrast, the central solder balls of image 2 when seen at an oblique angle look as shown in image 4. Although there is no bridging in image 2, the difference in solder ball diameter between the inner and outer solder balls is very clear. So this solder ball diameter variation is sufficient to flag this device for at least further investigation, or, more likely, replacement. Therefore measuring and comparing the BGA solder ball diameters offers the opportunity to identify popcorning even if the most obvious signs (bridges) are not present in the x-ray images.

Image 3: Typical x-ray image of good reflowed solder balls under a BGA.

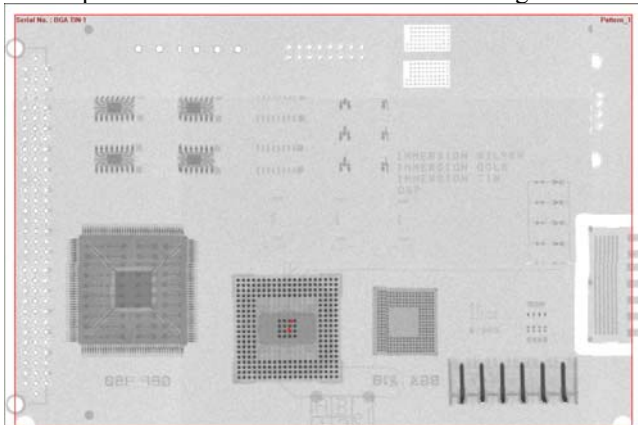
Image 5: X-ray navigation map of test board produced during 'Lead-Free Experience 4'.

Image 5 shows the layout of the connectors and other components on the board as well as being used by the x-ray system to locate the positions of any failures through a location rectangle superimposed on this map.

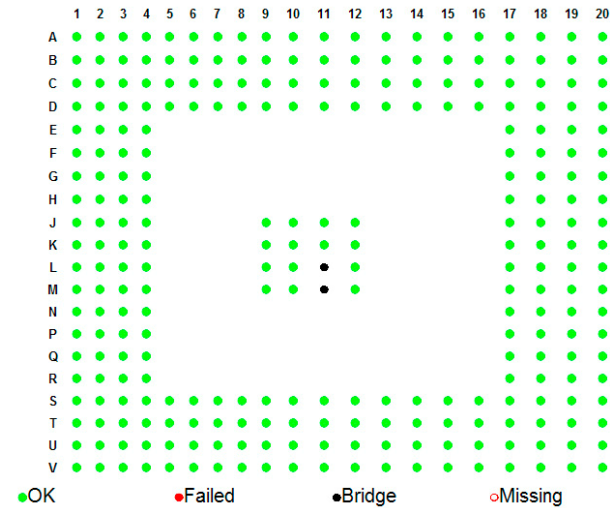
The results of the diameter measurements for each solder ball in each board analysed are shown below. The identification of each solder ball is shown in schematic in image 7. The solder ball designation could be simply defined in the software to coincide with on-board labelling, if required. Diameter measurement limits could have been set easily within the software, such that any solder ball that would measure outside of a user defined range would be indicated within the schematic diagram as a failure and therefore fail of the whole device. This feature was not used in this experiment. Instead the measured ball diameters could be easily exported into Excel spreadsheets for data manipulation and evaluation.

Image 7: Solder ball designation for diameter measurements under the BGA.
