COMMON PROCESS DEFECT IDENTIFICATION OF QFN PACKAGES USING OPTICAL AND X-RAY INSPECTION

ABSTRACT

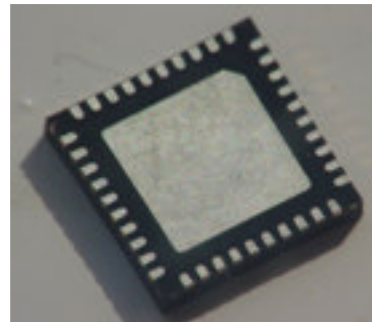
Image 1: Optical image of QFN package terminations

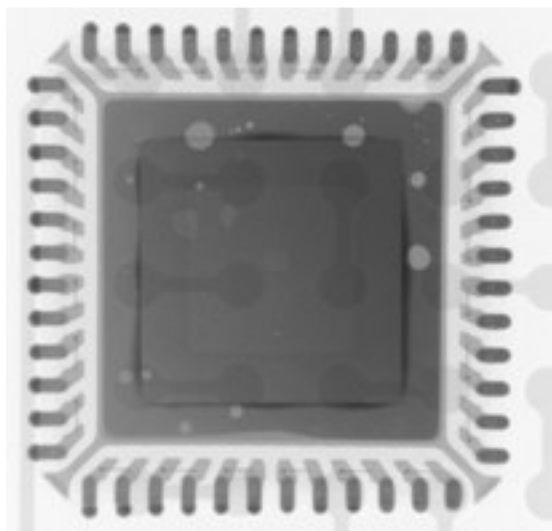
Image 2: X-ray image of QFN post reflow

The use of x-ray inspection for investigating QFN packages has been helped by recent developments made in 2-dimensional (2D) x-ray inspection equipment [1 – 3]. In particular, the improvements in resolution magnification and greyscale sensitivity, especially when inspecting at oblique angle views. In addition, new x-ray systems include digital x-ray imaging detectors, which have enhanced greyscale range as standard, that enables far better visual separation of similarly dense features [3] so as to ensure the best effective identification and analysis (see image 2).

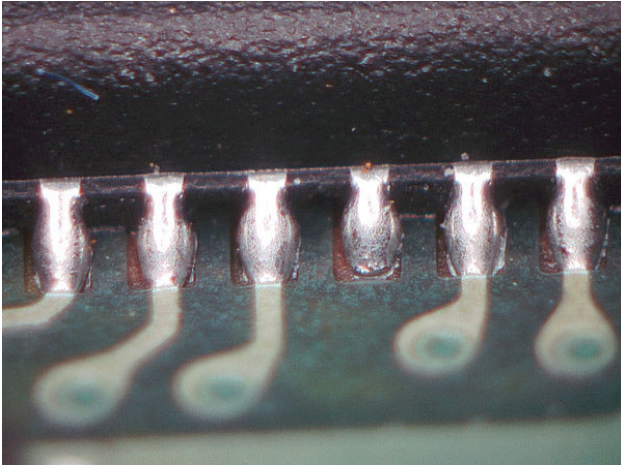
Image 3: Optical image of edge termination solder joints on a QFN component. The component supplier has managed to achieve an optimum plating finish on the terminations which has allowed a 'classically perfect' fillet to form during reflow, which includes coverage of the side terminations.

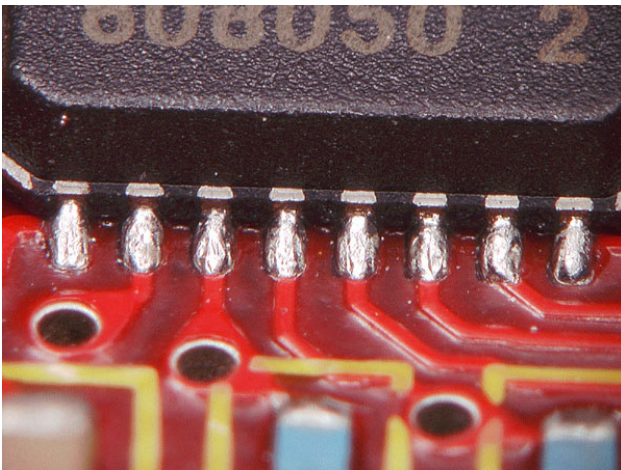
Image 3a: Optical image of edge termination solder joints on a QFN component. This shows satisfactory solder fillets on the edge terminations but there is no substantial wetting of the side terminations. This type of view is far more commonly found during real manufacture.

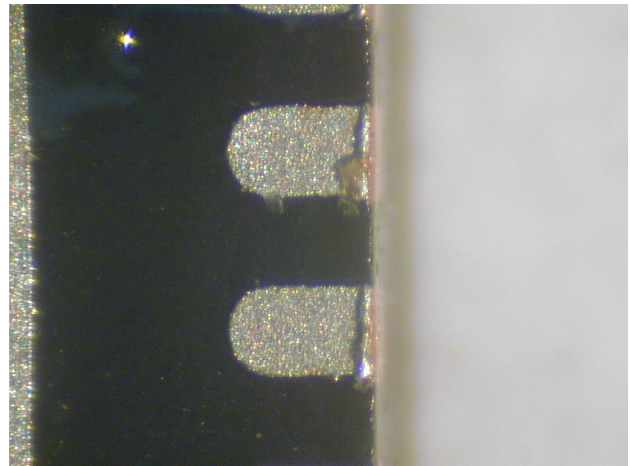
Image 4: Optical image of the base of a QFN showing typical pad burring that may be seen on edge-terminations. This is caused by poor component singulation of the lead-frame during device manufacture.

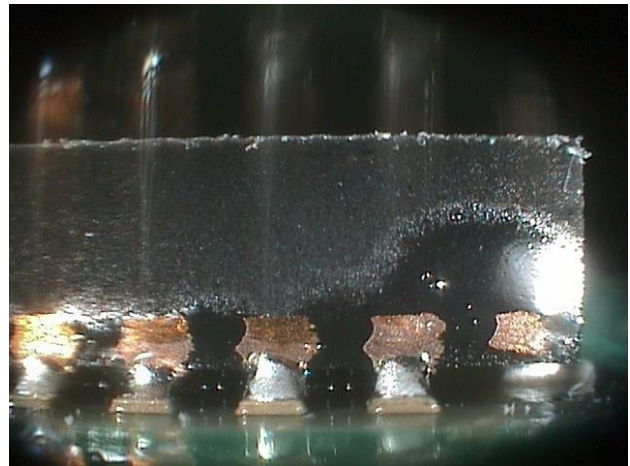
Image 5: Optical image of the edge of a QFN post reflow. The right most joint has not been made successfully and should be compared to the other joints shown. This has been caused by excessive paste being applied to the central QFN pad and/or excessive voiding occurring in the central pad during an inadequate reflow profile. These conditions make the QFN 'float' on the central pad during reflow, which raises the package above the board more than normal, and so interferes with the capillarity action of the reflow process. These issues have also lead to variation in the solder quality on the side fillets. Issues with the QFN central pad cannot be seen by visual inspection and it is possible that other factors may also cause failed edge terminations. X-ray inspection (see later) allows a non-destructive view of the central QFN pad to confirm, or otherwise, the analysis.

As described previously (image 5), the most likely cause of this voiding variation is because of solder paste deposition variability during printing owing to the un-optimised nature of the production line used at the 'Experience'. An excess of solder paste may cause the QFN to 'float' over the pad and, as a result, impact on the heat dissipation and/or the efficiency of operation of the package. It should be noted that the excessive voiding levels were slightly more pronounced on convection reflowed boards compared to vapour phase. However, the difference was small and there were many convection reflowed boards that showed little, or no voiding. Any discrepancy in the data may have been caused instead by the wetting efficiency of the PCB solder finish and/or the stencil design.

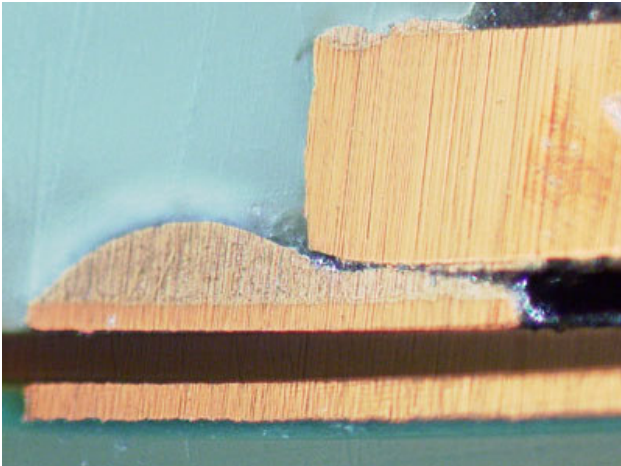
Image 6: Micro-section of a QFN on a flexible circuit. The QFN has 'floated' due to excessive paste deposited on the central pad and/or excessive voiding in the centre pad. This has caused an open joint. This failure may have been exacerbated by solderability or burring issues in the component plating.

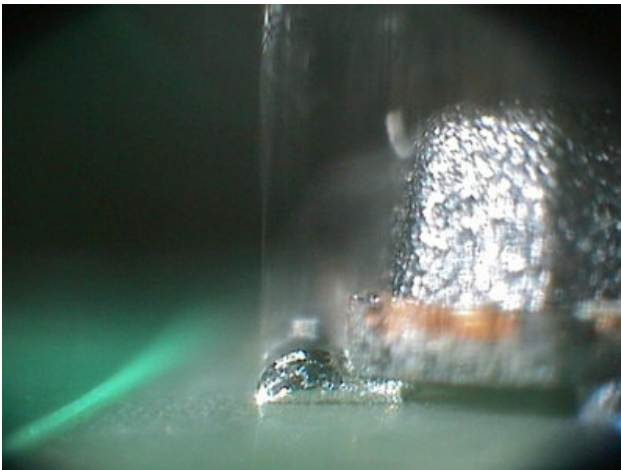
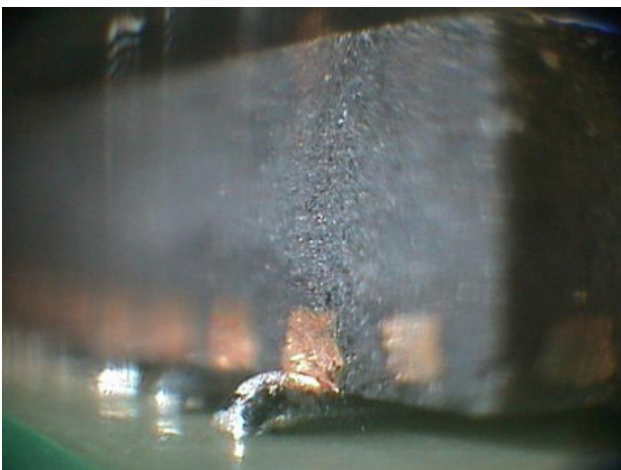
Images 7 & 8: Optical images of a QFN showing that solder joints have formed on the base of the device. However, if the side terminations do not wet then the visual appearance of the joints may vary making it very

difficult for AOI inspection. The land pattern should still extend outside of the component footprint and the length of the pad designed under the part should extend to the end of the metalisation. Although good wetting of the side terminations is not required to make a good QFN edge joint, if they are present then it is often a great help to inspecting their quality in the real world of manufacturing.

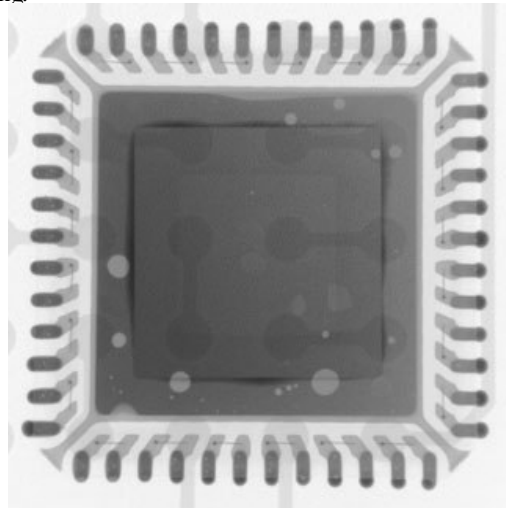
Image 9: X-ray image of a QFN reflowed onto a flexible circuit showing good, consistent edge joints and very little voiding under the central pad.

As with the optical inspection images, the test boards have provided useful reference x-ray images to show the difference between good and bad QFN joints (see images 9 and 10). The defects were more likely caused by the rush to produce boards from an ad hoc assembly line at an exhibition rather than by any underlying issues with the use of QFN packages under convection or vapour phase reflow. The good joints remained good, even after the thermal cycling.

It was in the central pad however, clearly seen under x-ray inspection, where the voiding levels varied dramatically across all the test boards. This was irrespective of the reflow method used on the board and this variation was especially marked on the QFNs placed on the flexible circuits (see images 9 and 10).

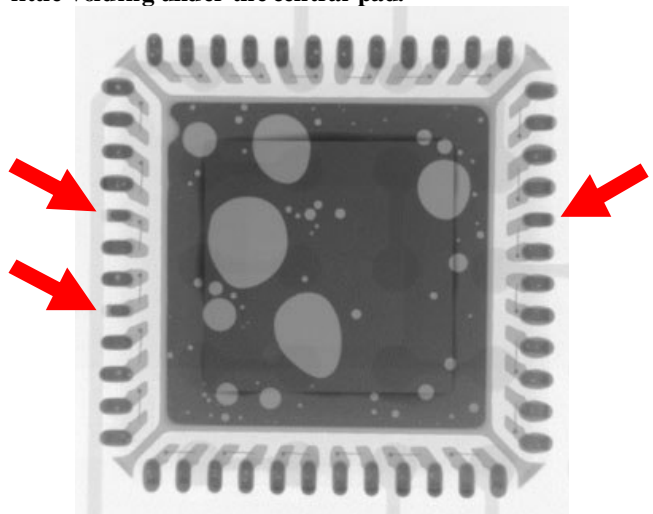
Image 10: X-ray image of a QFN reflowed onto a flexible circuit showing open edge joints (as seen by the shape of, and less material in, the joint – see arrows and

compare with image 9 and the substantial voiding under the central pad.

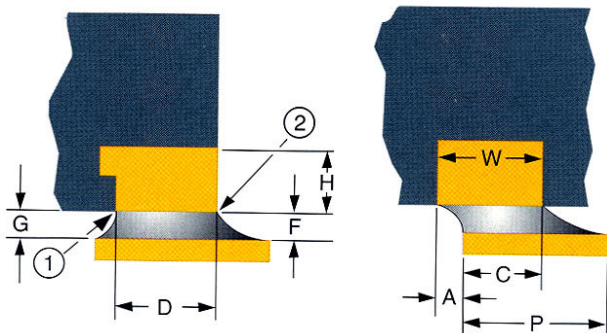
Diagram 1: Optical inspection criteria for QFNs (from IPC-A-610D – see reference 6).

Optical inspection criteria for QFNs are suggested by the IPC-A-610D document [6]. In particular, it suggests that the maximum side overhang of the termination relative to the pad be at most 25% of the pad width for class 2 and 3 products. It also suggests that the minimum end joint width is at least 75% of the total pad width for class 2 and 3 products (see diagram 1).

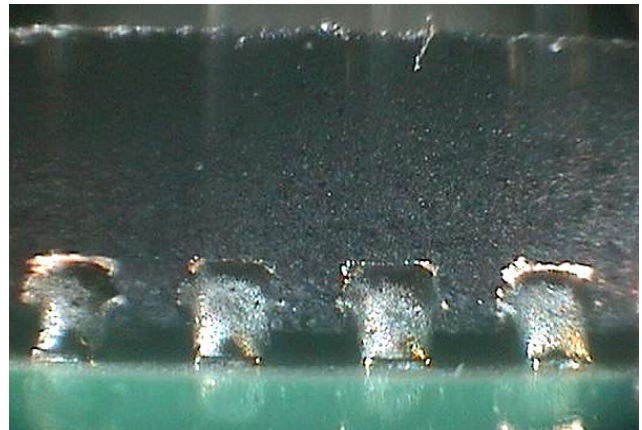
Image 11: Optical image of acceptable QFN edge terminations. Solder fillets should exist if the design incorporates pads that extend beyond the package width.

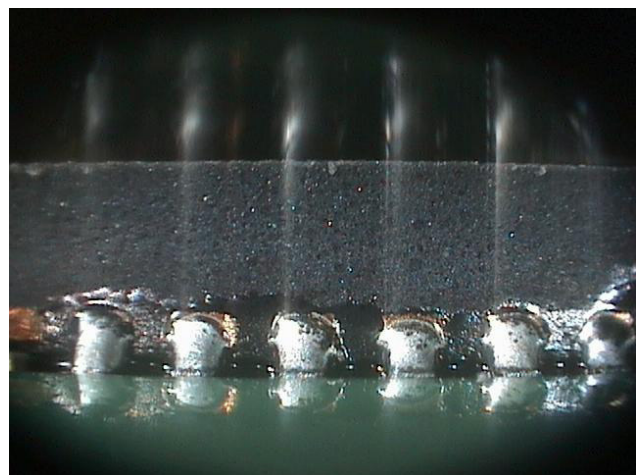
Image 12: Optical image of acceptable QFN edge terminations. Solder fillets should be visible to a minimum of 75% of the width of the termination.

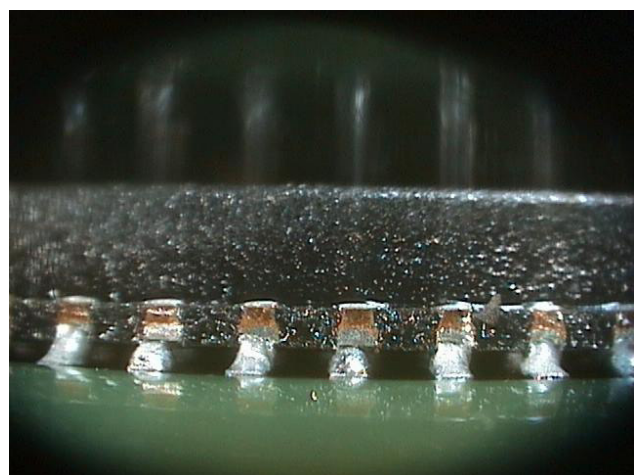
Image 13: Optical image of unacceptable QFN edge terminations. The solder rise is limited and an open joint can be seen. The package is also 'floating' above the surface of the pads.

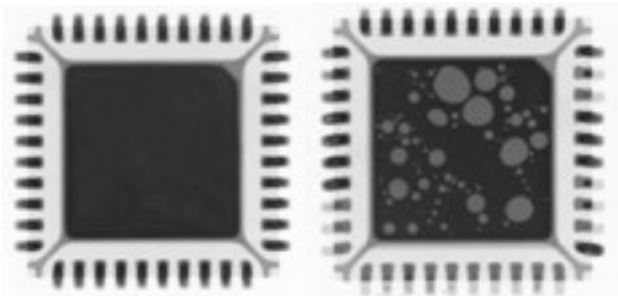
Image 14: X-ray images of QFNs following reflow showing an ideal example (left) and an unsatisfactory one. Note the joint variations in the unsatisfactory example which can be clearly seen, even at low magnification, and therefore, with this x-ray system, does not require additional higher magnification or oblique angle views to be taken.

As there is no explicit recommendation in the IPC-A-610D as to acceptable x-ray inspection criteria for QFNs, the following are suggested as a guideline. Further information on suggested x-ray inspection guidelines for a range of typical components used in production can be seen in reference 8. A comparison between x-ray images of a good and a bad QFN are shown in images 9 and 10 as well as in image 14.

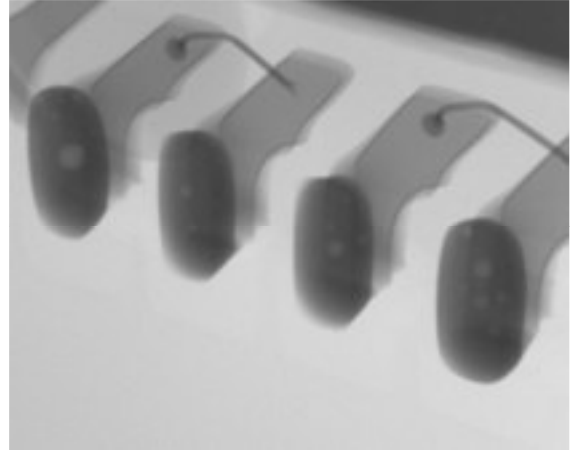
Image 15: Target Condition of QFN edge joints where showing a moderate level of voiding within joints is acceptable. All joints have reflowed.

Images 15 – 17 and 18 – 20 show three example x-ray images of QFNs. Each indicates a different level of joint condition acceptability for the edge and central terminations respectively. These are:

1. Target Condition – An image of the ideal solder joint when inspected with x-ray.
2. Acceptable Condition – An image of the joint appearance in the x-ray system that is at the maximum permitted level of deviation from that set as the target condition. These joints will not require rework but suggest a process review be considered to improve the joint quality towards the target condition. This level is the minimum condition for the production process.
3. Defect Condition – An image of the joint appearance in the x-ray system indicating an unacceptable joint. The

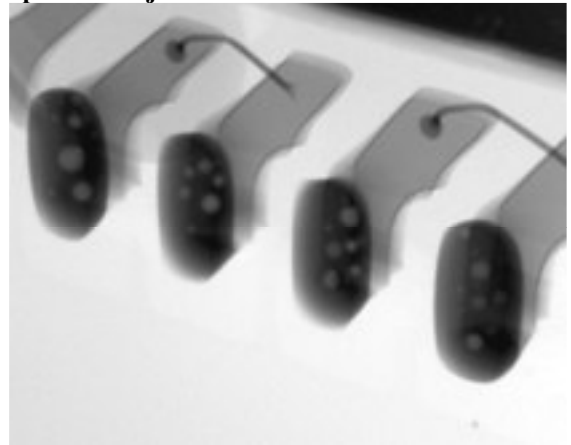
Image 16: Acceptable Condition of QFN edge joints showing an increased level of voiding within the joints but well within any action level.

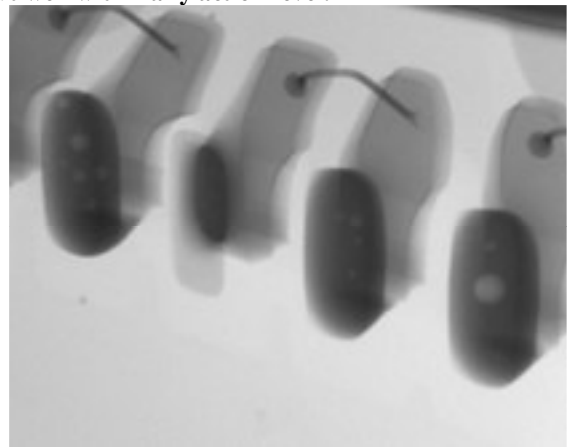
Image 17: Defect Condition of QFN edge joints showing insufficient solder in a joint (this example) or voiding exceeds 20% of the joint area of a single joint.

cause(s) of this condition should be investigated and necessary corrective action to the process applied. Possible rework of such joint conditions should wait until the process has been corrected.

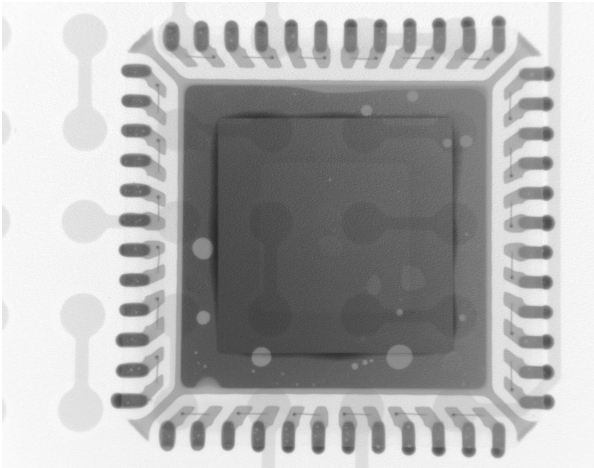
Image 18: Target Condition - Moderate level of voiding under the central termination is acceptable. All edge terminations are consistent.

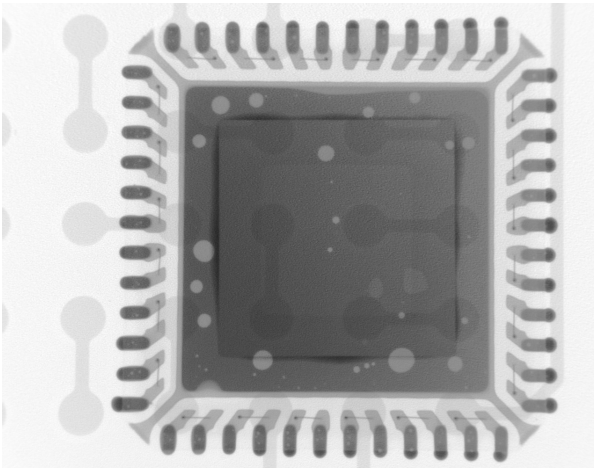
Image 19: Acceptable Condition –An increased level of voiding is seen in the central termination.

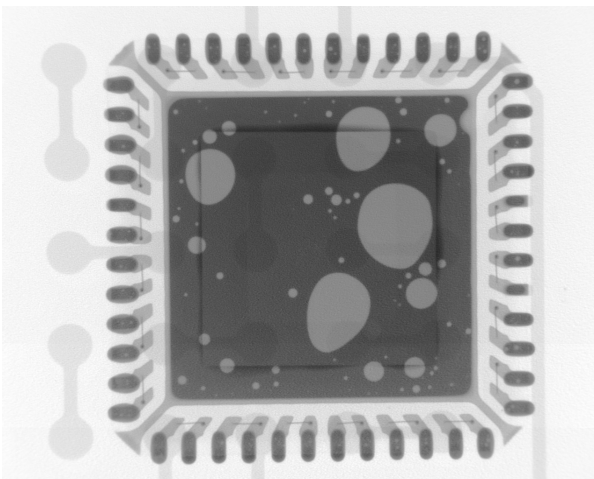
Image 20: Defect Condition - Excessive level of voiding is seen both in total quantity and for individual voids. Open joints are also seen in the edge terminations.

The maximum void percentage in any one termination, including the central pad, should be less than 20% of the joint area. In the case of multiple voids, the maximum void percentage should be also less than 20%. It should be noted that blind vias in the centre pad area, or through-vias with solder mask capping the opposite side of the board, are likely also to contribute to voiding.
